BRAKE DISCS TROUBLE TRACER CHART

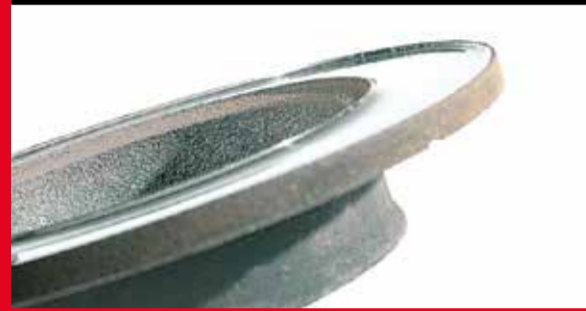
Excessive wear. Disc thickness is lower than the 'Minimum Thickness'.

What caused it? Discs were not inspected regularly or replaced at the correct moment.
What is the effect? Lower performance, excessive noise and vibration while braking
How do you fix it? Fully inspect the braking system and associated components. Replace any failed components and fit new discs with the right torque and sequence recommended by the manufacturer during tightening.

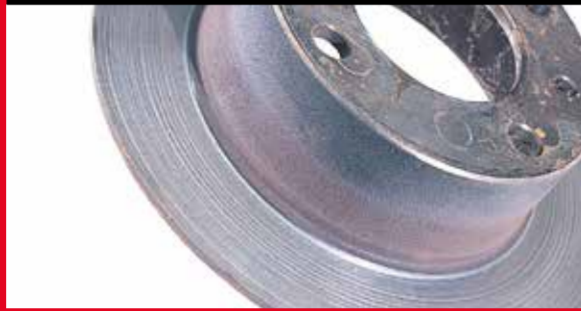
Disc heavily used with surface grooves.

What caused it? Excessive or full brake pad wear results the brake pad backplate contacting the disc (metal to metal). This will make grooves in the disc surface.
What is the effect? Increased stopping distances/ very low braking efficiency and grinding noise.
How do you fix it? Change discs and pads. Make sure the wear indicator is working.

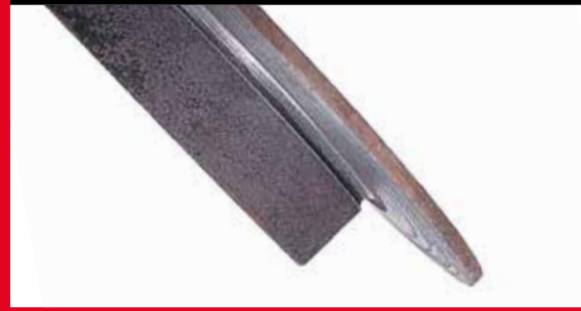
Deep grooving between pad and disc.

What caused it? Extreme pad and disc wear may result in movement of the backplate within caliper. In this case, the backplate of the worn pad has separated from its seat within caliper causing grooving between hat and disc surface.
What is the effect? Lower braking efficiency with a longer pedal stroke and more noise.
How do you fix it? Change discs and pads. Check and, if necessary, repair the caliper.

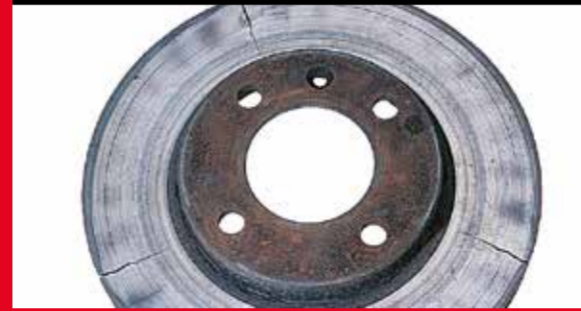
Radial cracks/blue spots corresponding to the venting frames.

What caused it? Blue spots are a result of rising cracks caused by metallurgical change in the surface material making it hard and brittle. This is common in cases of overloading the brakes beyond normal design limits. This could result from aggressive driving, excessive payload or intensive/unusual brake use.
What is the effect? Reducing brake performance, noise and vibrations.
How do you fix it? Replace discs, avoid brake system misuse and make more efficient use of engine/gears to lower the speed.

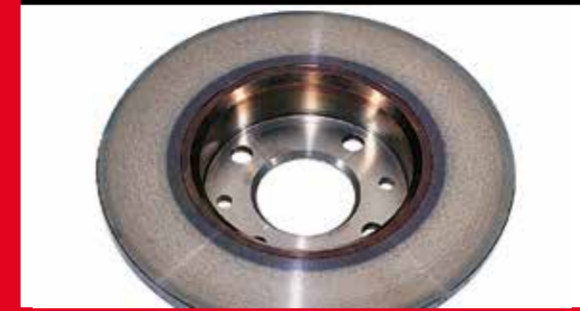
Colouring of changing intensity and shades (blue, violet or golden).

What caused it? Poor bedding-in. If not accurately bedded, surfaces where friction appears get overheated. This leads to a metallurgical change on the friction surface.
What is the effect? Bad brake efficiency caused by decreased friction. Vibrations can occur which may lower the life of the pad and disc.
How do you fix it? Change the discs and hold on to the right bedding procedure, i.e. moderate use of brake during the first 200 kilometers.

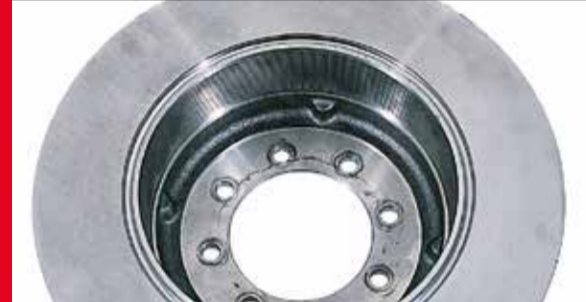
Contact surface distortion, and/or visual cracks around the fitment holes.

What caused it? Tightening sequence incorrect, not enough tightening torque used.
What is the effect? Vibration on initial brake applications.
How do you fix it? Replace discs and adhere to both correct fitment sequence and torque settings recommended by the manufacturer.

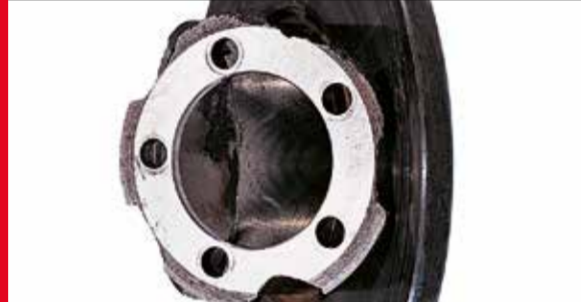
Detached or distorted Hub contact surface.

What caused it? Needless tightening and failure to observe recommended torque and sequence by the manufacturer during tightening.
What is the effect? Complete brake failure, disc contact surface is detached.
How do you fix it? Fully inspect the braking system and associated components. Replace any failed component and install new discs.

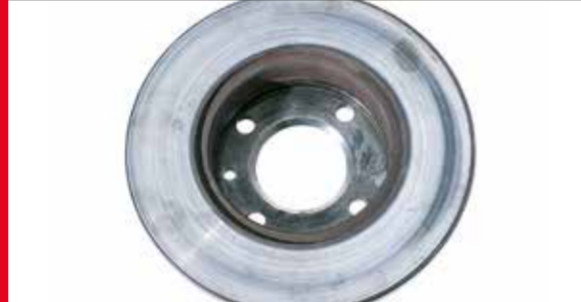
Disc areas show some blue spots/darker color. Indication of localized overheating.

What caused it? Excessive hub run-out and uneven disc-to-pad contact generates vibration that causes localized heat.
What is the effect? Constantly increasing noise and vibration.
How do you fix it? Correct wheel hub run-out within correct tolerances.

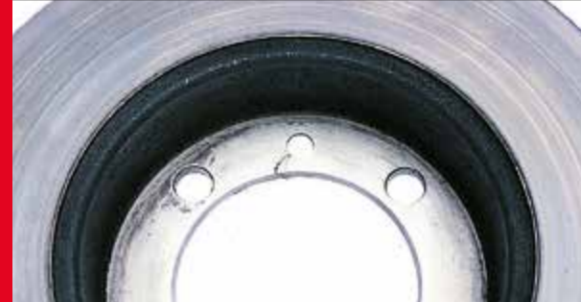
Distortion of the hub contact surface and/or cracking around it.

What caused it? Too much severe tightening torque used on positioning screw.
What is the effect? Vibrations observed from the first brake applications onwards
How do you fix it? Change discs avoiding excessive tightening torque. Positioning screws are just expected to ensure that the discs are positioned correctly.

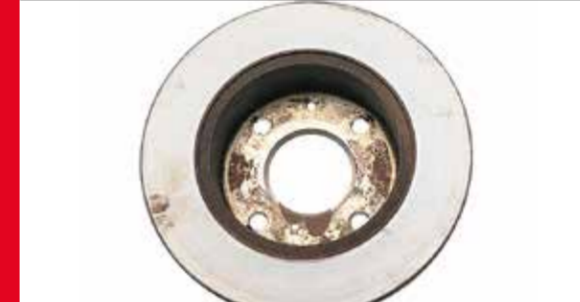
Hub surface with dirt and/or rust.

What caused it? Contamination on hub surface. This results in misalignment during mounting leading to irregular contact between pad and disc surfaces and irregular wear of the disc.
What is the effect? Disc thickness variation which leads to oscillation of the disc surface that will result in noise and vibration. The effect becomes increasingly bigger with use.
How do you fix it? Remove disc and carefully clean surfaces of wheel hub and disc. This erases rust and other debris. Control that there is no distortion or damage to the support surface.

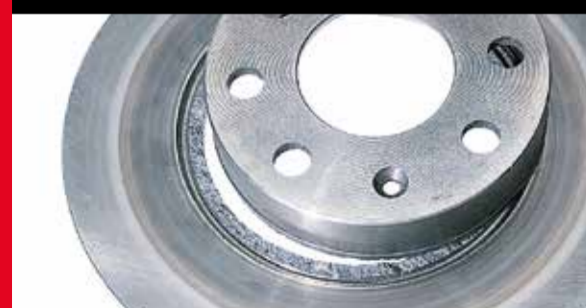
Disc hat detached from the braking surface.

What caused it? Mechanical stress caused by misalignment and wrong assembly/positioning of the caliper and the disc. This causes asymmetrical wear of the braking surface.
What is the effect? Loud noise and vibration during braking with entire mechanical breakdown after detachment.
How do you fix it? Fully inspect the braking system and associated components. Replace any failed components and install new discs observing recommended torque and sequence by the manufacturer.

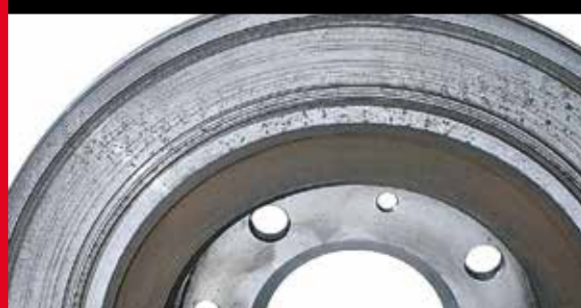
Grooving on the disc.

What caused it? Loose rough/sharp particles like dirt, road or water. Or badly mixed friction material between pads and disc.
What is the effect? Lower brake efficiency caused by reduced braking contact surface and noise during braking and normal driving.
How do you fix it? Install new pads and discs.

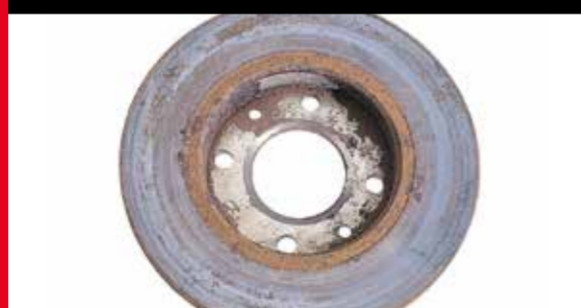
Contamination of the disc surface, glazing and/or dark spots.

What caused it? Friction material deposits on disc surface. This usually appears where bad quality brake pads have been installed.
What is the effect? Vibration, bad braking efficiency and tough pedal.
How do you fix it? By installing great quality brake pads with friction material that suit the brake and the vehicle.

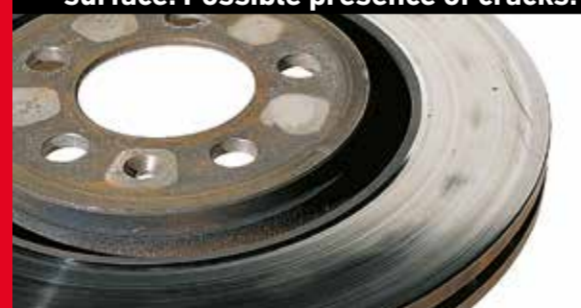
Unbalanced wear of braking surfaces. Blue spots in the middle of braking surface. Possible presence of cracks.

What caused it? Incorrect assembly of the caliper and/or pads can cause the pads being at a different angle to the disc, each side wearing at changed rates. Blue spots are generated by severe localized overheating.
What is the effect? Progressive onset of vibrations, due to heat spots. Probable reducing of the brake efficiency.
How do you fix it? Inspect and repair caliper. Replace pads.

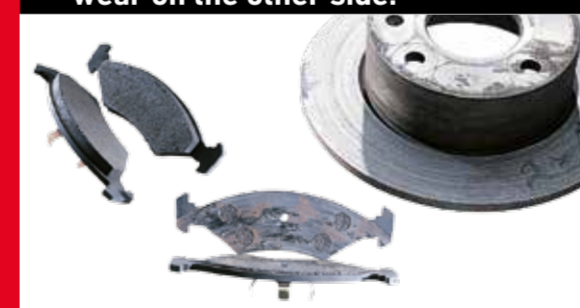
Unbalanced wear of brake pads. Major wear on one pad with minimal wear on the other side.

What caused it? One brake pad is in constant contact with disc. This causes the pad to wear down to the metal backplate.
What is the effect? Constant grinding noise, vibration and low braking efficiency. Possible unbalanced braking action with car pulling to one side.
How do you fix it? Check caliper, replace or repair. Change brake pads and discs if necessary.
